Name Of Dam: Mink Creek

Location: Albemarle County, State of Virginia

Inventory Number: VA 00352

PHASE I INSPECTION REPORT

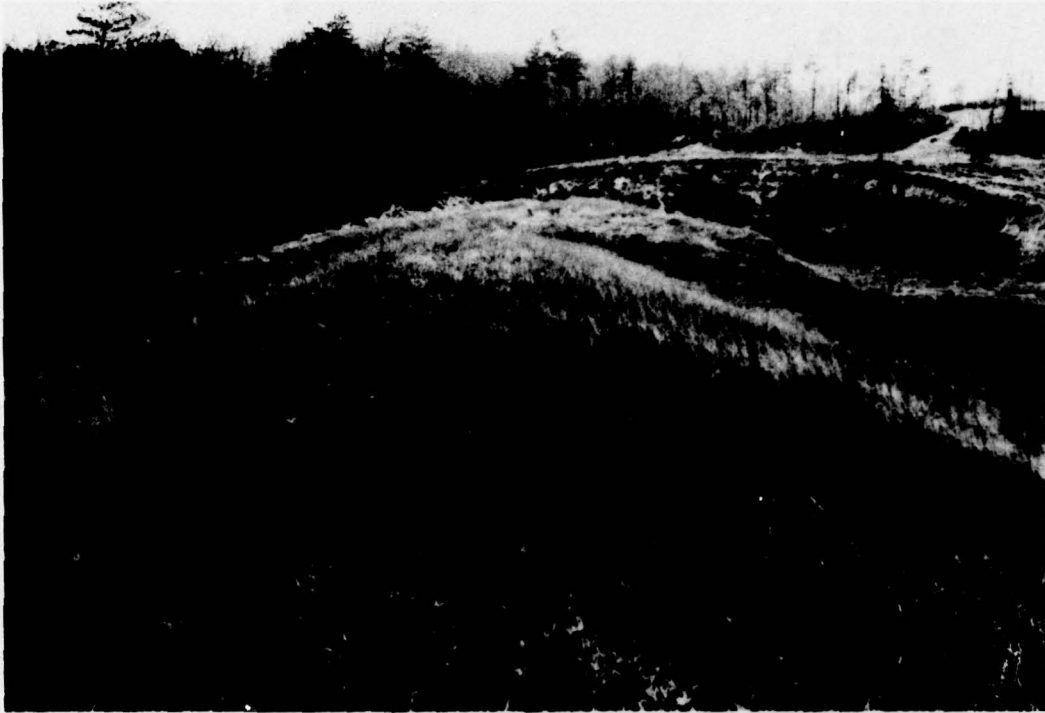
PHOTO 1. View of Top of Dam Looking Toward Emergency Spillway

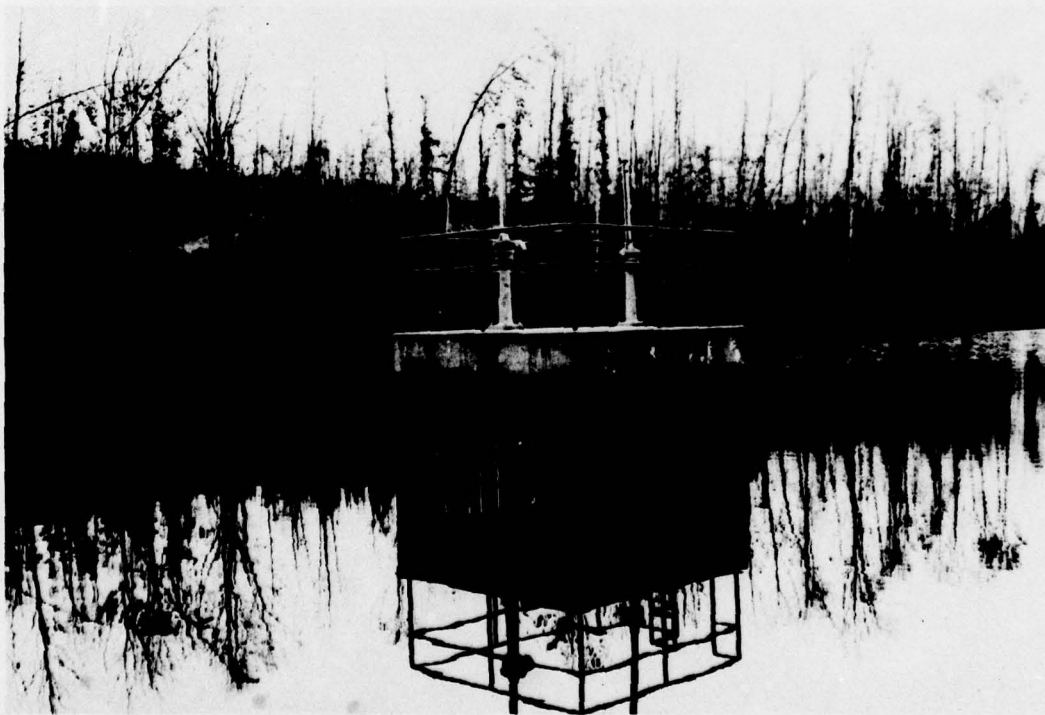
- 3.1.3 Appurtenant Structures: The concrete structures including the riser (see Photo 2) and impact basin (see Photos 3 and 4) are intact without damage. The only deficiency observed was some minor settlement and erosion of the earth backfill near the ends of the concrete walls for the impact basin.

PHOTO 2. Riser of Outlet Structure in Reservoir

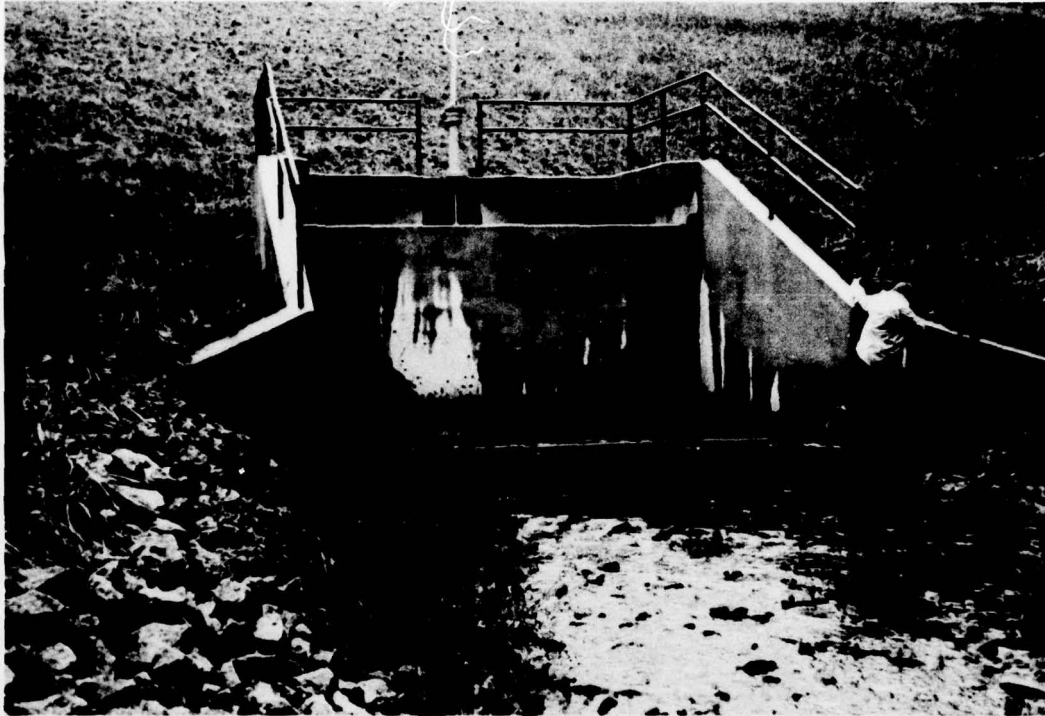
PHOTO 3. Impact Basin Showing Baffle Wall, End Sill and Riprapped Exit Channel

- 3.2.4 Appurtenant Structures: The settlement and erosion of the backfill adjacent to the walls of the impact basin should be repaired with compacted soil and the area should be reseeded. Surface runoff should also be diverted.

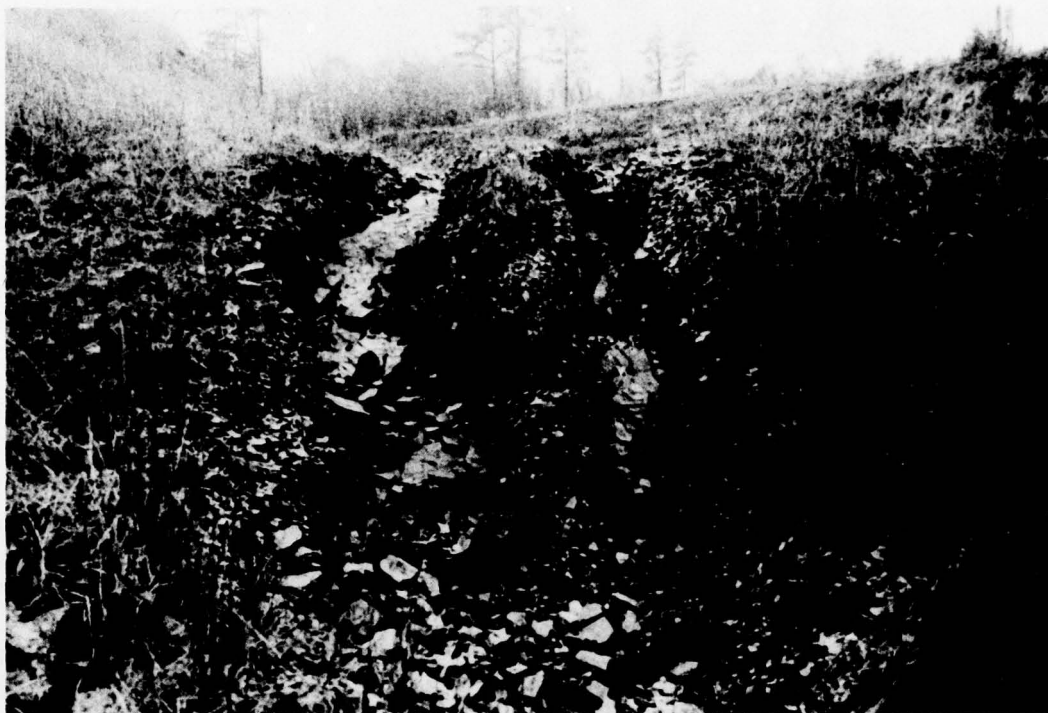
- 3.1.4 Emergency Spillway: The spillway can function for overflow conditions as designed, but there are some deficiencies which include erosion gullies (see Photo 5) in the approach channel at the shoreline, minor clear seepage in the discharge channel and moderate erosion with rock breakage in the cut slopes. The discharge channel of the emergency spillway is shown in Photo 6.

PHOTO 5. Erosion at Approach Channel to Emergency Spillway

- 3.2.2 Emergency Spillway: The erosion gullies in the approach channel should be repaired and protection against erosion from surface runoff should be provided. Surface runoff should be diverted by drainage ditches for erosion protection in both the approach and exit channels. The erosion and sloughage in the cut slopes do not appear to be serious at this time.

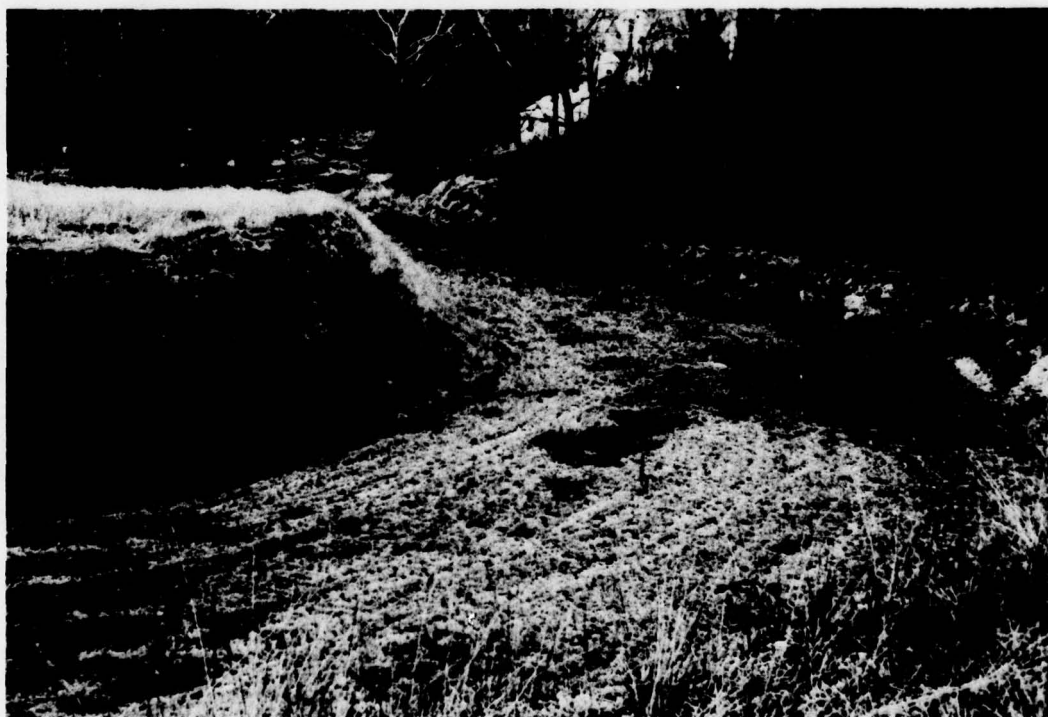
PHOTO 6. Downstream View of Emergency Spillway
